Heavy Vehicle Inspection Report

Report # HVI324
 Location: Huston,TX
 Inspection Date: 13-Feb-2018
 Inspector Name: Steve white

Vehicle Category: Wheel Loader
 Vehicle Name: CATAPILLER 908-H
 Vehicle #: ABCD1234
 VIN #: 1FUJBBG45LN2288
 Meter Reading: 2617 Hours
 Model/Year: 2010
 Operator Name: Harry and Jack

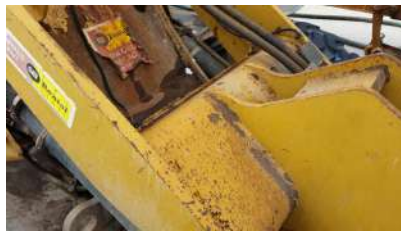
6. Blade/Boom/Ripper Condition

6	Blade/Boom/Ripper Condition	Boom is in good condition Light surface rust No visible cracks,bad welds or rot	<input checked="" type="checkbox"/>	<input type="checkbox"/>	<input type="checkbox"/>	<input type="checkbox"/>
7	Body Damage, wear or Modifications	Body in fair condition lots of surface rust. Roof could use paint job (see photo)	<input type="checkbox"/>	<input checked="" type="checkbox"/>	<input type="checkbox"/>	<input type="checkbox"/>
8	Brake Condition	Fluid leak at caliper Caliper needs replaced asap	<input type="checkbox"/>	<input type="checkbox"/>	<input checked="" type="checkbox"/>	<input type="checkbox"/>
9	Brake Fluid	Currently good but leaking at caliper Fluid condition good	<input type="checkbox"/>	<input checked="" type="checkbox"/>	<input type="checkbox"/>	<input type="checkbox"/>
10	Brake fluid reservoir	Keep eye on hose coming off reservoir	<input checked="" type="checkbox"/>	<input type="checkbox"/>	<input type="checkbox"/>	<input type="checkbox"/>

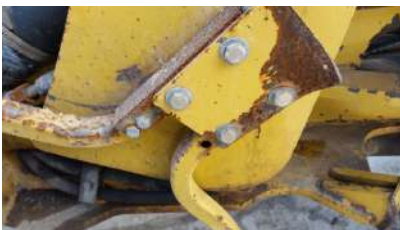
16. Damage, Loose or missing Parts /Accessory

16	Damage, Loose or missing Parts /Accessory	Left front fender bracket needs replaced but current fix is holding (see photo) Hood struts need replaced	<input type="checkbox"/>	<input checked="" type="checkbox"/>	<input type="checkbox"/>	<input type="checkbox"/>
17	Decals, Warnings/ Placards	Some decals fading but all are present	<input checked="" type="checkbox"/>	<input type="checkbox"/>	<input type="checkbox"/>	<input type="checkbox"/>
18	Doors	Functions properly but door glass doesn't open	<input type="checkbox"/>	<input checked="" type="checkbox"/>	<input type="checkbox"/>	<input type="checkbox"/>
19	Drive Axle		<input checked="" type="checkbox"/>	<input type="checkbox"/>	<input type="checkbox"/>	<input type="checkbox"/>
20	Electrical Equipments		<input checked="" type="checkbox"/>	<input type="checkbox"/>	<input type="checkbox"/>	<input type="checkbox"/>
21	Engine air filter	Fuel pump needs replaced part# 2325877 Head gasket small leak (see photo) All engine hoses in fair condition overall Cold start assist deleted from injection pump Air filter housing needs replaced lip is cracking	<input type="checkbox"/>	<input checked="" type="checkbox"/>	<input type="checkbox"/>	<input type="checkbox"/>
